REPORT OF PHASE I ENVIRONMENTAL SITE ASSESSMENT

CHELSEA SOUTH TRACT
SNAKE ROAD
RIDGELAND, JASPER COUNTY, SOUTH CAROLINA

JPEG PROJECT #2672-21

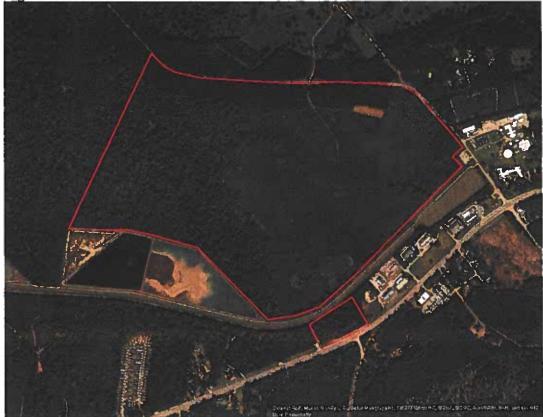
The following is a description and classification of the major habitat/community types identified within the site. Also noted with the description is an assessment of suitability for the listed species. A recent aerial photograph of the site for reference in the following descriptions is included as Figure 2.
